## Integrated Physical Needs Assessment (IPNA)

**Building:** Luna Park Housing Corp.  
2879 West 12th Street, Brooklyn, NY 11224

## OBJECTIVE, PROCEDURES, AND LIMITATIONS

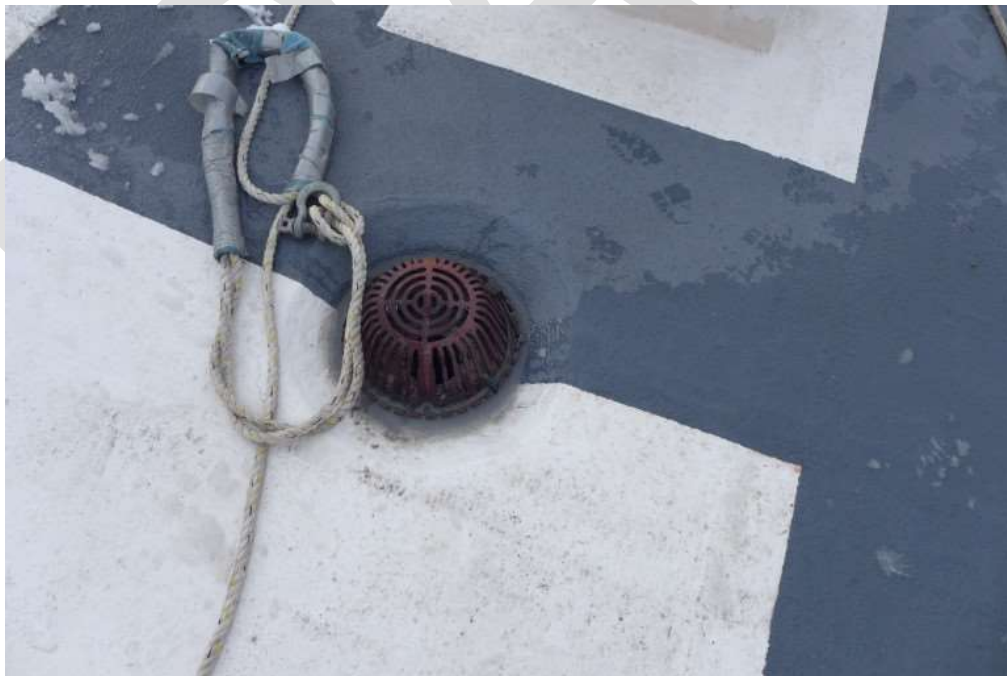
**Building 2 – Roof Drain**

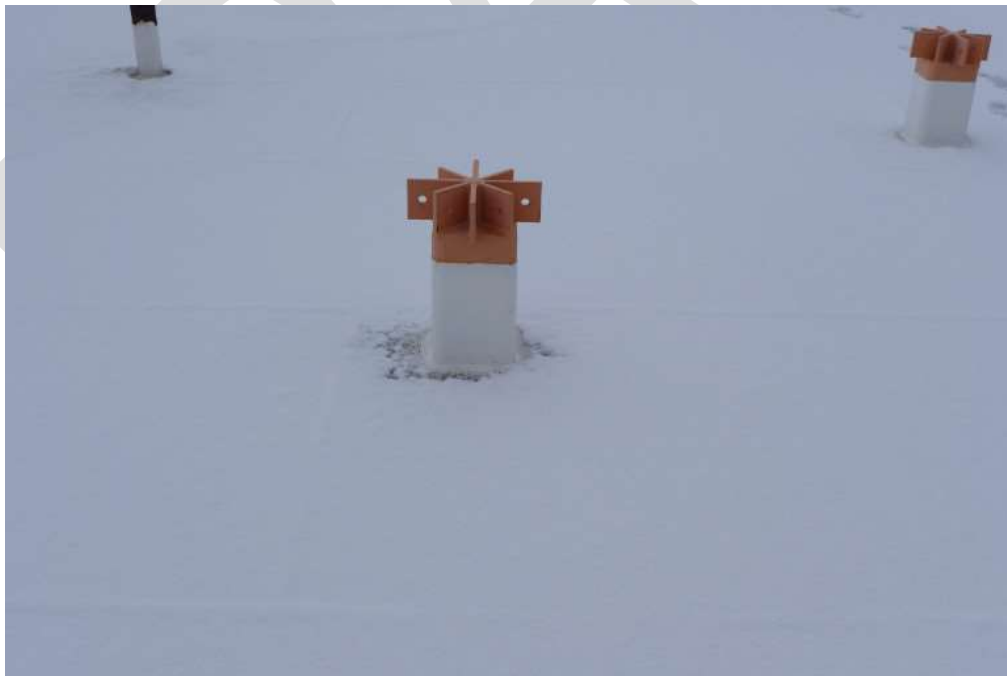
Scaffold tie-back installed during roof project.

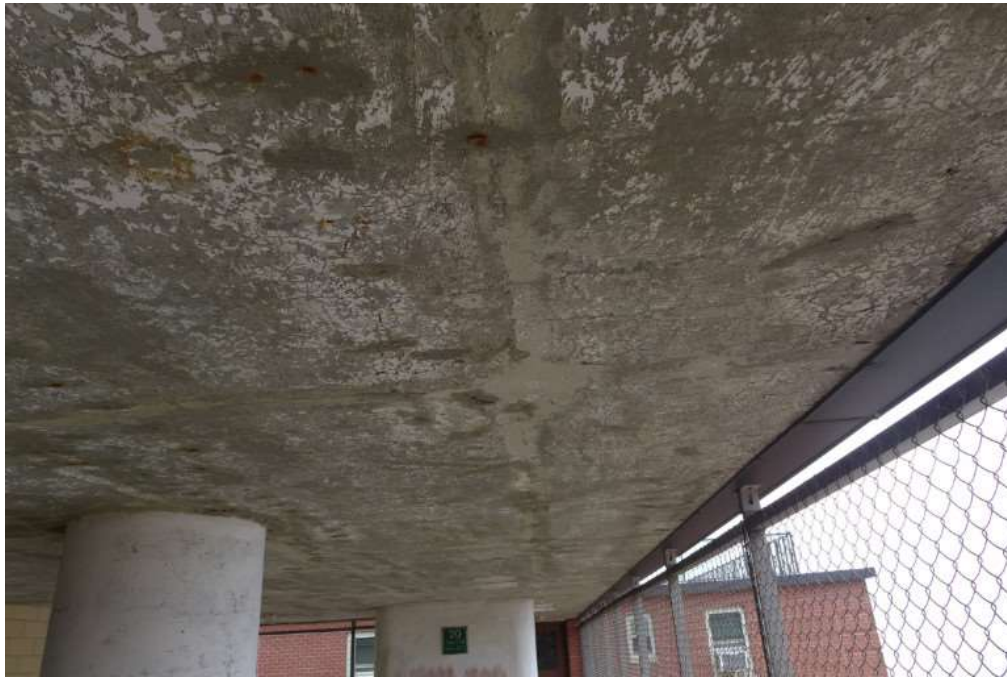
Underside of exterior walkway. Note the dark metal edging (on the right hand side) that conceals and holds up the broken concrete at the edges.

| Site Inspection | | Material | | Condition | Site Inspection Narrative / Recommendations | |
|---|--|---|---|---|---|---|
| Foundation | | Concrete | | Fair | The overall structure of the building is in good condition, with the exception of the covered walkway edges which need to be repaired. L&M inspected the cellars of each building, #1-5. Overall the concrete structures inside the cellar crawlspaces appeared to be in fair condition. Several locations of underside repairs and minimal concrete column repairs were noted. Slight undermining of the foundation wall was observed, however the wall is supported on the column footings and this is not a structural issue. Most of the deterioration noted in the cellars were located on/near the cellar entrance ramps and the concrete beams above the cellar crawlspaces. There were several locations where the corroded reinforcement was visible and the concrete had previously spalled off. | |

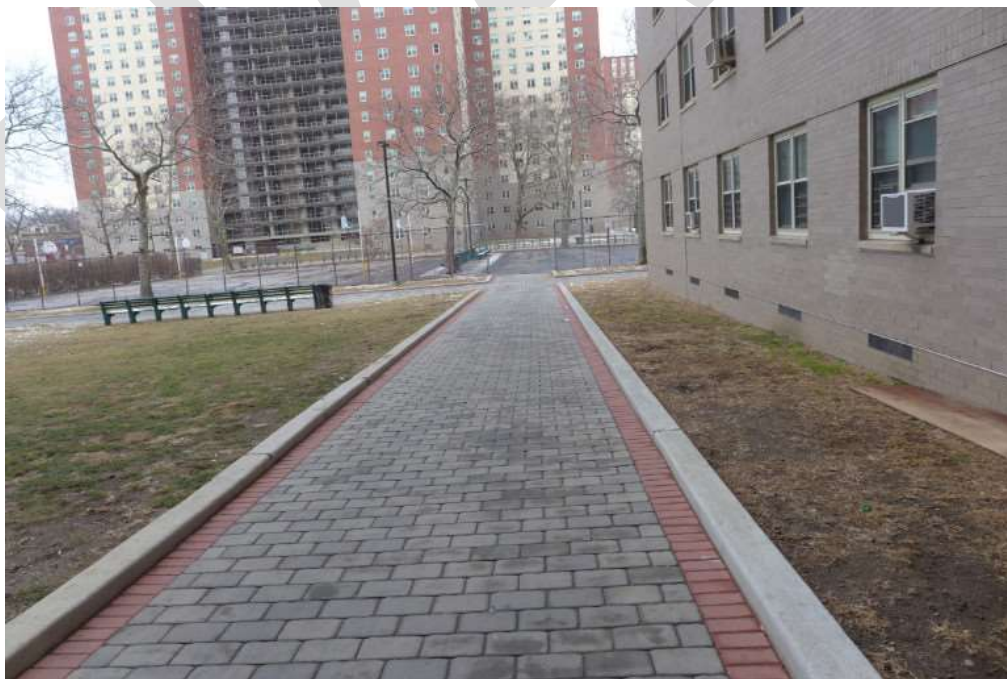
New Sidewalks

| Site Inspection | | Material | | Condition | Site Inspection Narrative / Recommendations | |
|---|--|---|---|---|---|---|
| Sidewalk | | Concrete | | Fair | Few uplifted concrete flags at the sidewalk should be replaced and the dropped granit curbs should be reset. | |

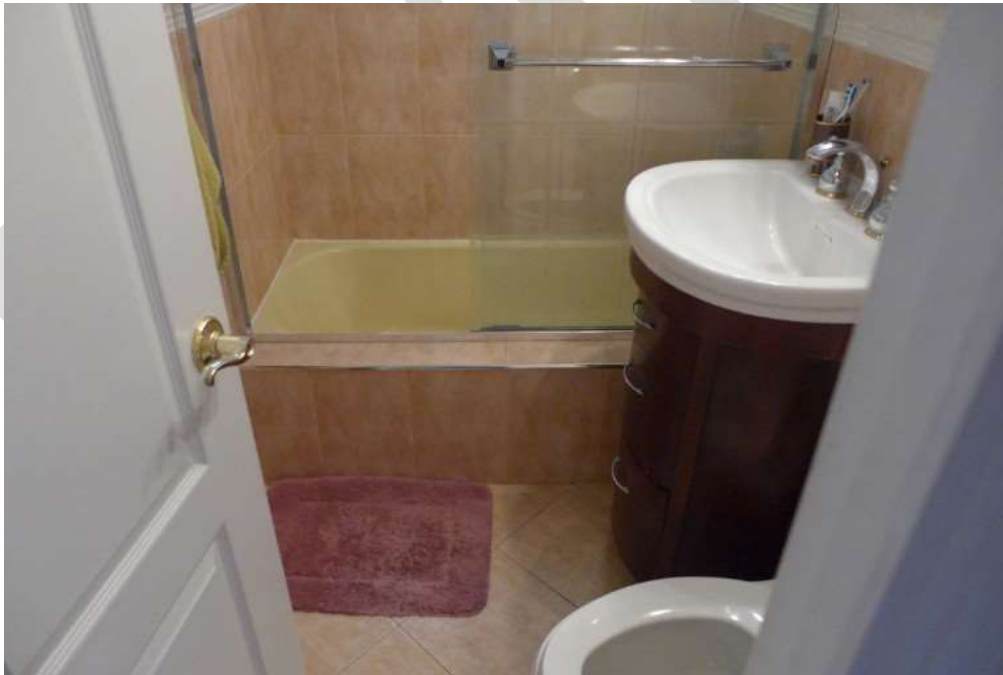
Typical bathroom renovated by owner.

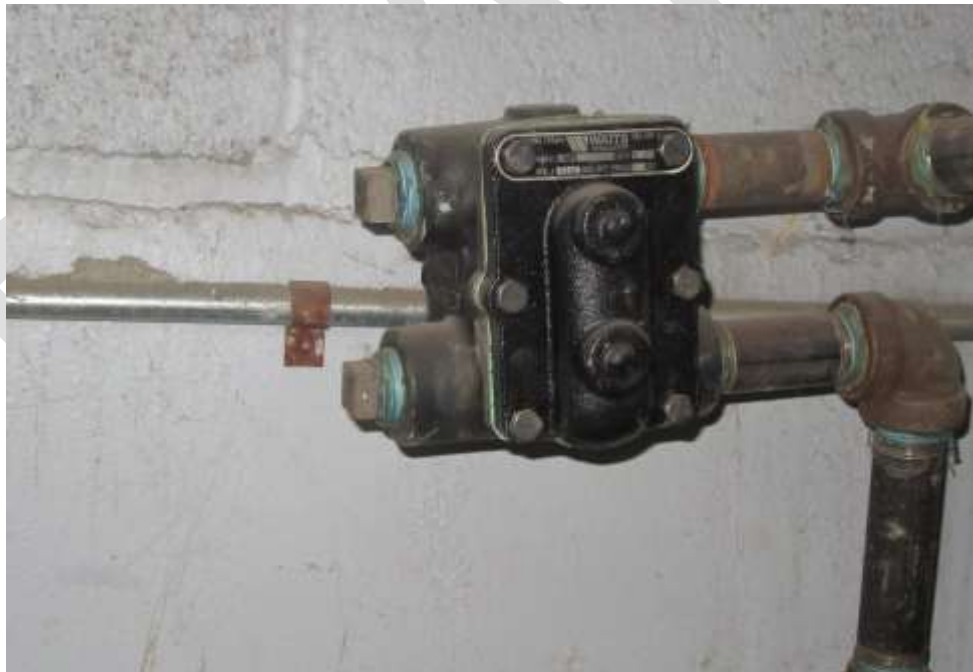
Typical Common Area F&T Trap

| Recommended Energy Efficiency, Water Conservation, Resiliency, and Physical Needs Improvements | | | | | |
|---|---|---|---|---|---|
| Steam Traps Replacement | Common Areas | Building Systems | \$ 40,000 | \$ 9,520 | Low |

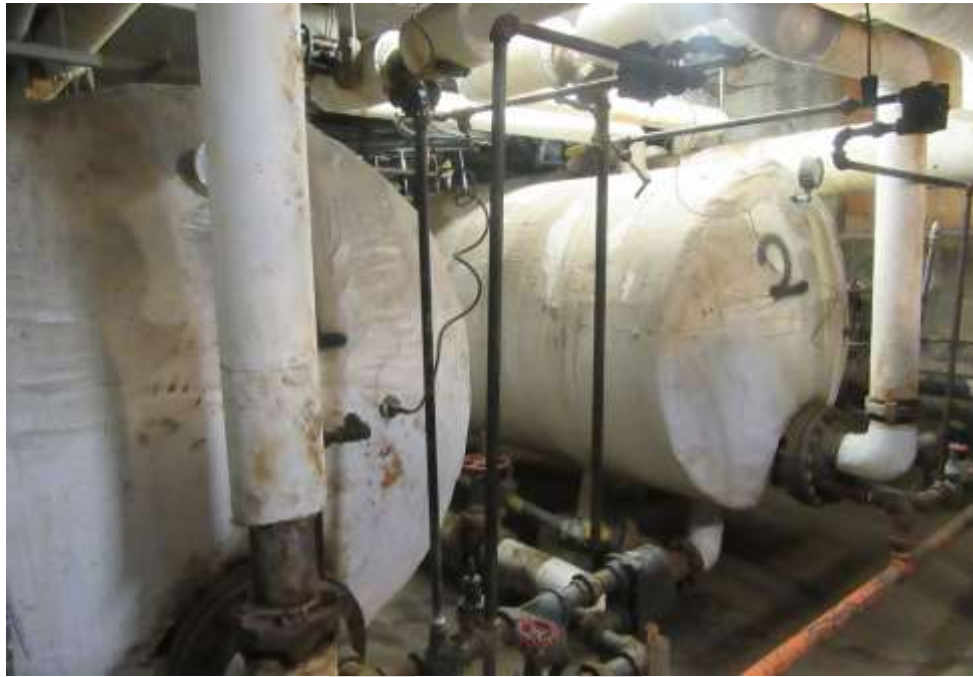
Typical DHW Storage Tanks

| Recommended Energy Efficiency, Water Conservation, Resiliency, and Physical Needs Improvements | | | | | |
|---|---|---|---|---|---|
| Replace hot water heaters | N/A | Building Systems | \$ 450,000 | \$ 20,740 | Low |

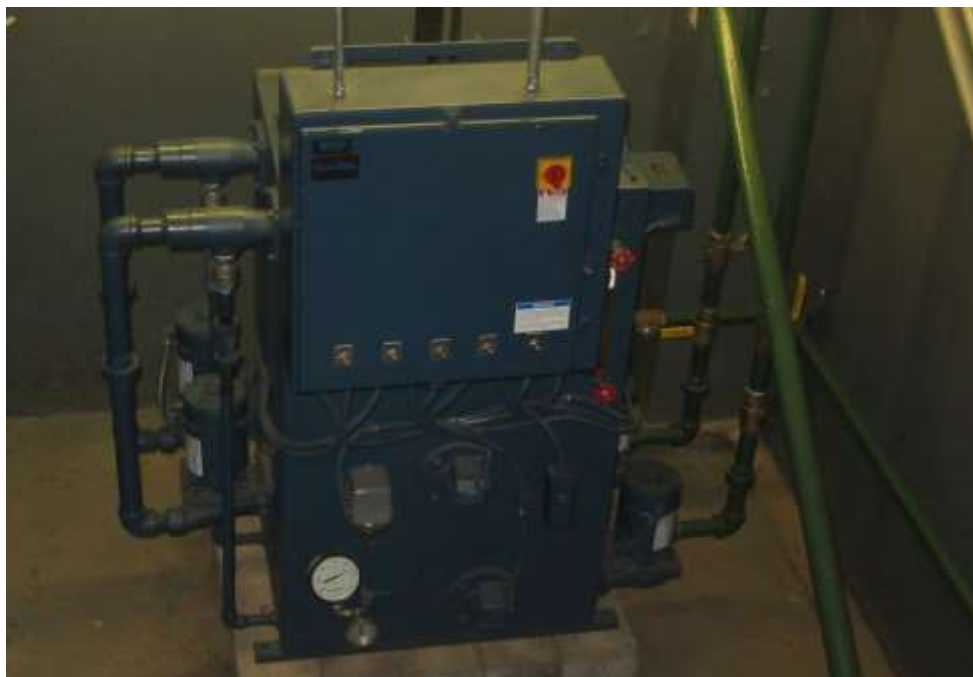
Typical Vacuum Pump Set

| Recommended Energy Efficiency, Water Conservation, Resiliency, and Physical Needs Improvements | | | | | |
|---|---|---|---|---|---|
| Replace Vacuum Pumps | 1 per Buildings | Building Systems | \$ 240,000 | | None |

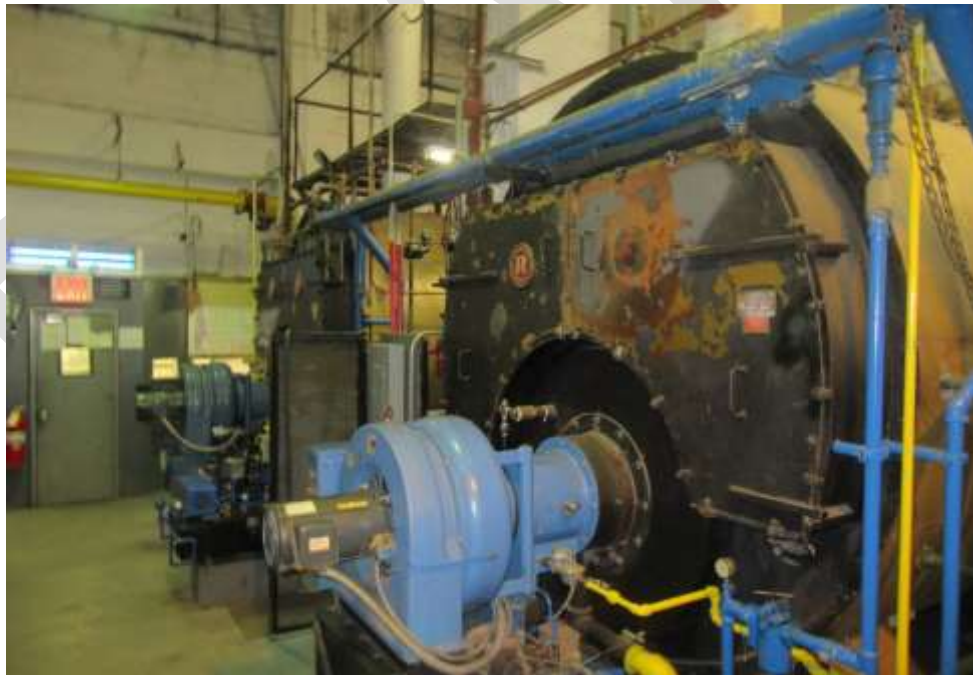
Building Boilers

| Recommended Energy Efficiency, Water Conservation, Resiliency, and Physical Needs Improvements | | | | | |
|---|---|---|---|---|---|
| Upgrade Heating Plant | New Boilers, Burners & Controls | Building Systems | \$ 1,500,000 | \$ 18,135 | None |

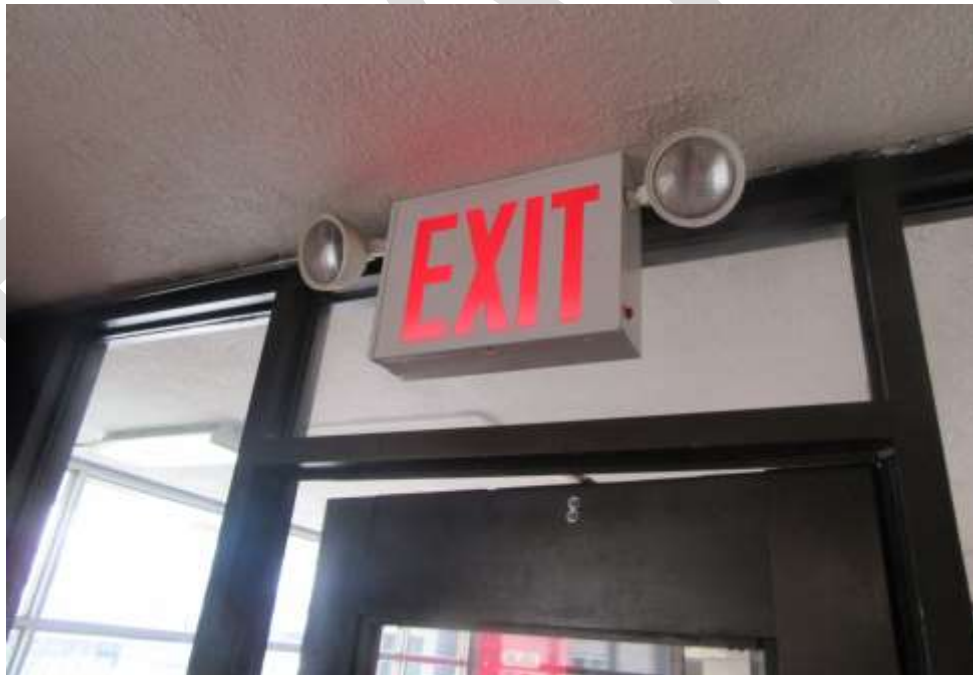
Typical Exit Sign with emergency Heads

| Electrical | Description | Electrical Inspection Narrative / Recommendations |
|---|---|---|
| Other Elec. Util. | CHP Units Serving Each Building | The building has limited number of emergency fixtures with Exit signs in the lobby and cellar exit. it is highly recommended to add emergency fixtures on the hallways and stairwells to protect tenants during power outage. |

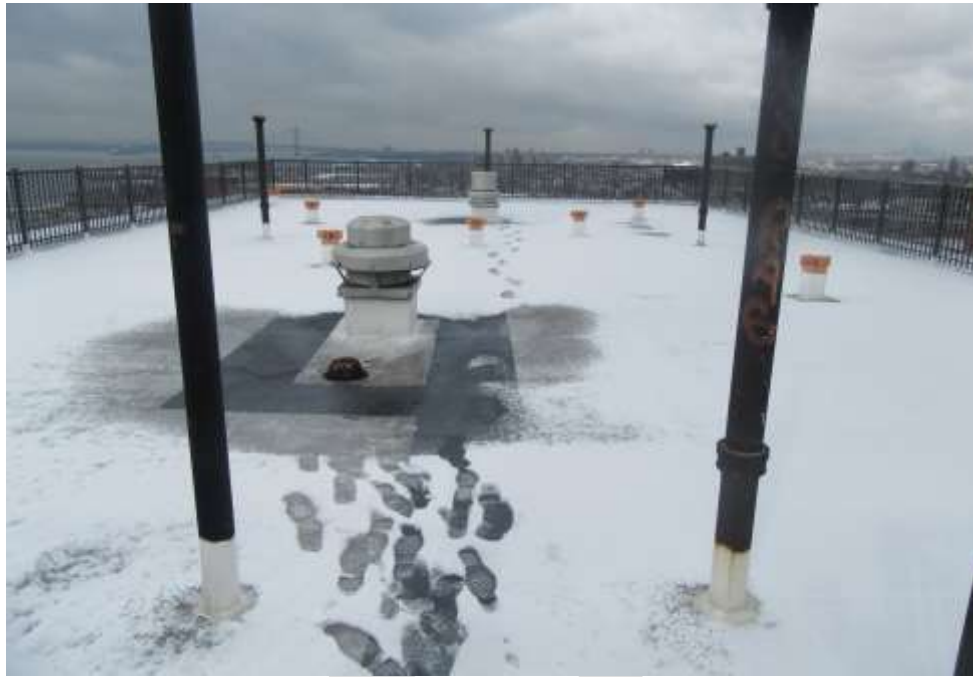
Typical Roof Exhaust Fans

| Recommended Energy Efficiency, Water Conservation, Resiliency, and Physical Needs Improvements | | | | | |
|---|---|---|---|---|---|
| Replace Exhasut Fans | Fans replacement & Clean Ventilation Fans | Building Systems | \$ 180,000 | | High |

| Recommended Healthy Rehab Interventions | | |
|---|---|---|
| Repair/replace roof top fans, and seal duct work | Medium Impact, Med-Hi Cost | |

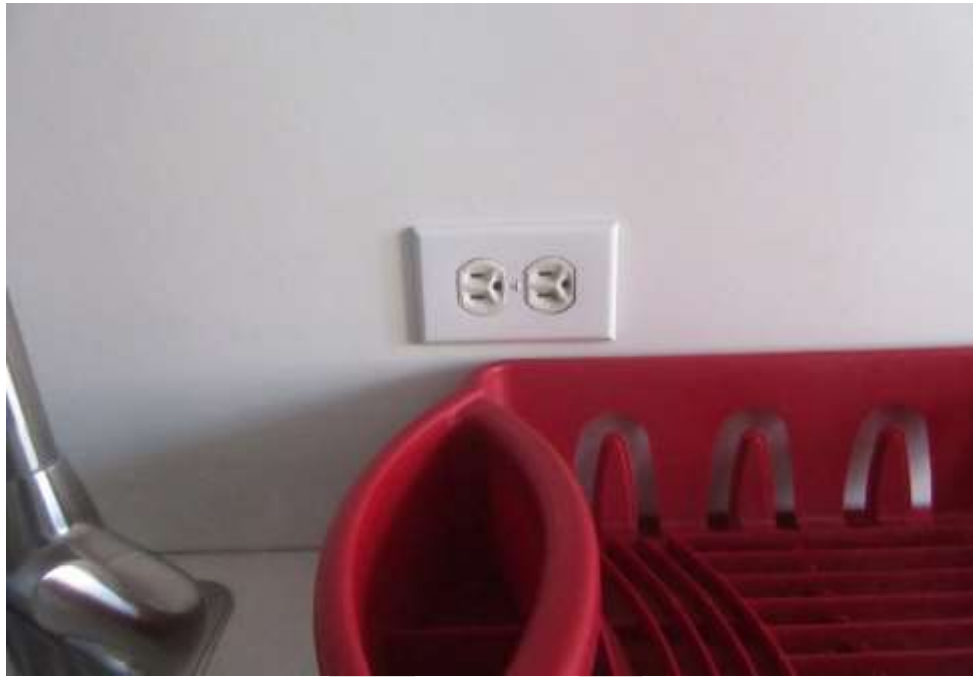
Apartment Non-GFIC Outlet in Kitchen

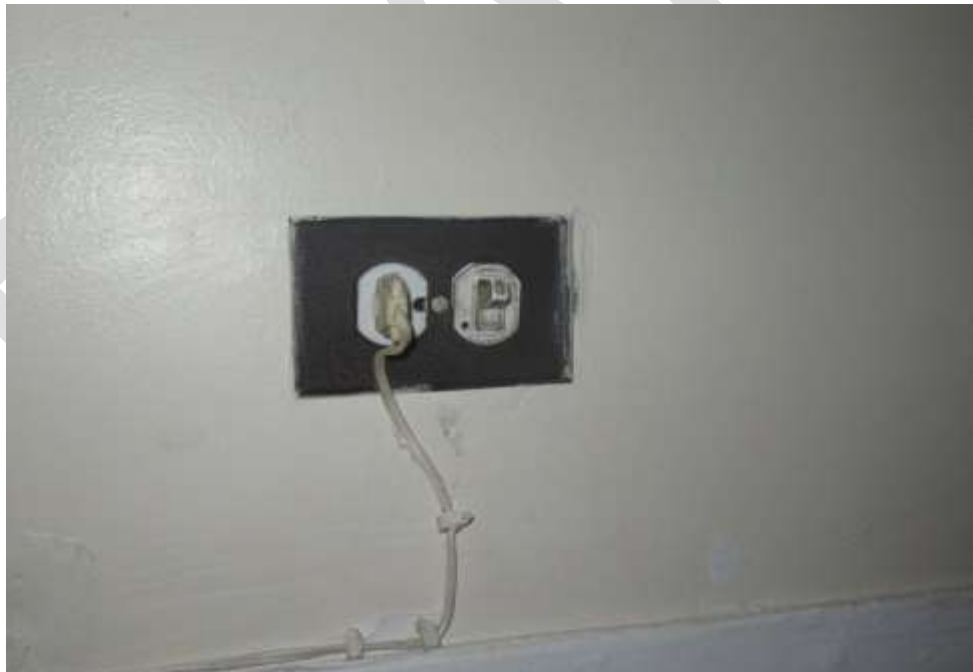
Original Outlet/Switch

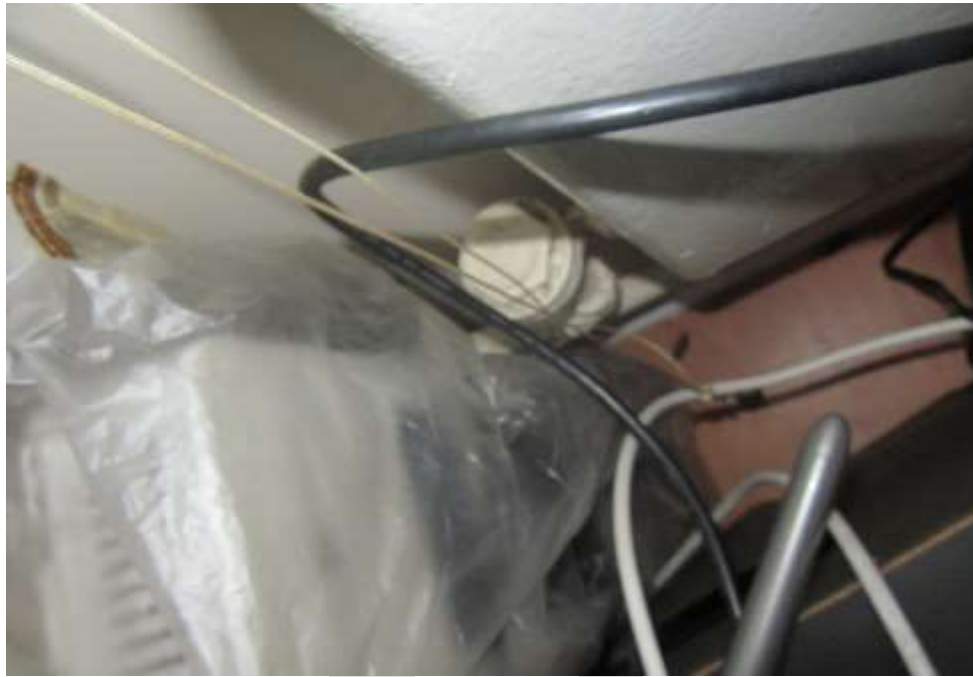
Typical Apartment Radiator Trap

| Recommended Energy Efficiency, Water Conservation, Resiliency, and Physical Needs Improvements | | | | | |
|---|---|---|---|---|---|
| Steam Traps Replacement | Apartments | Apartments | \$ 1,012,000 | \$ 11,815 | Low |

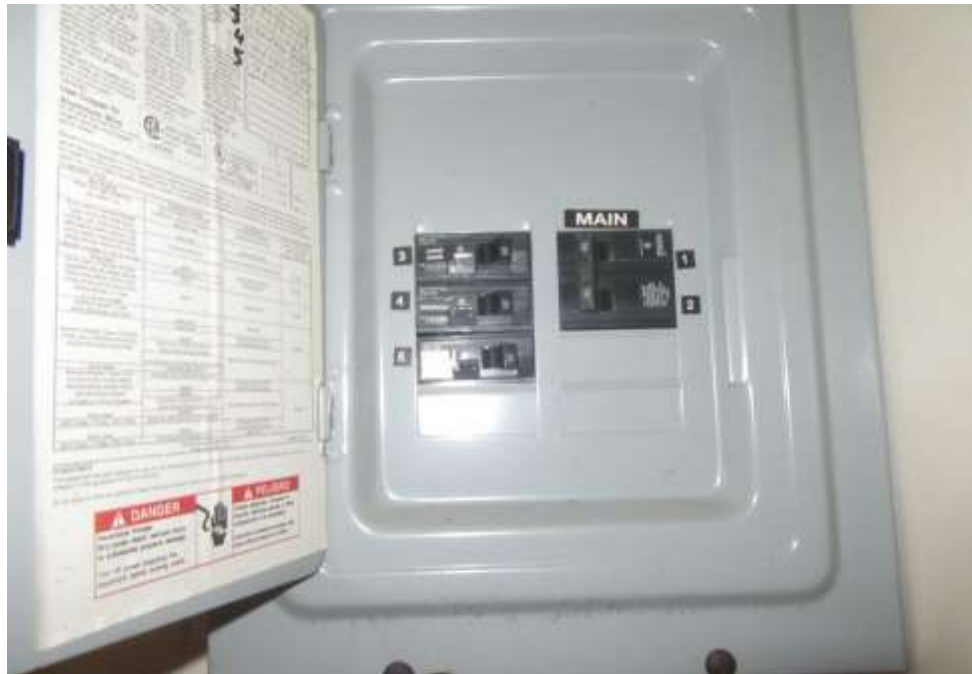
Typical Apartment Update CB Panel

| Apartments | | | | | |
|---|---|---|---|---|---|
| Entryway | 1 | 1 | 1 | Fair | The apartments visited have been renovated over the years. Most units have circuit breaker panel and few only still have the original fused panels. Tenants install new circuit breakers as needed when they install new equipment. The lighting fixtures in the bathrooms, kitchens, and bedrooms are different from one apartment to another but generally seem to be in good condition. majority of the apartments use compact fluorescent lighting with few incandescent and LED lamps in some areas. Majority of the apartments have original lighting fixtures, switches, and outlets but they are all in good condition. Majority of the outlets in the bathrooms and kitchens have GFI outlets. Finally, it was noted that majority of the apartments have battery operated combination CO/Smoke Detector in the |

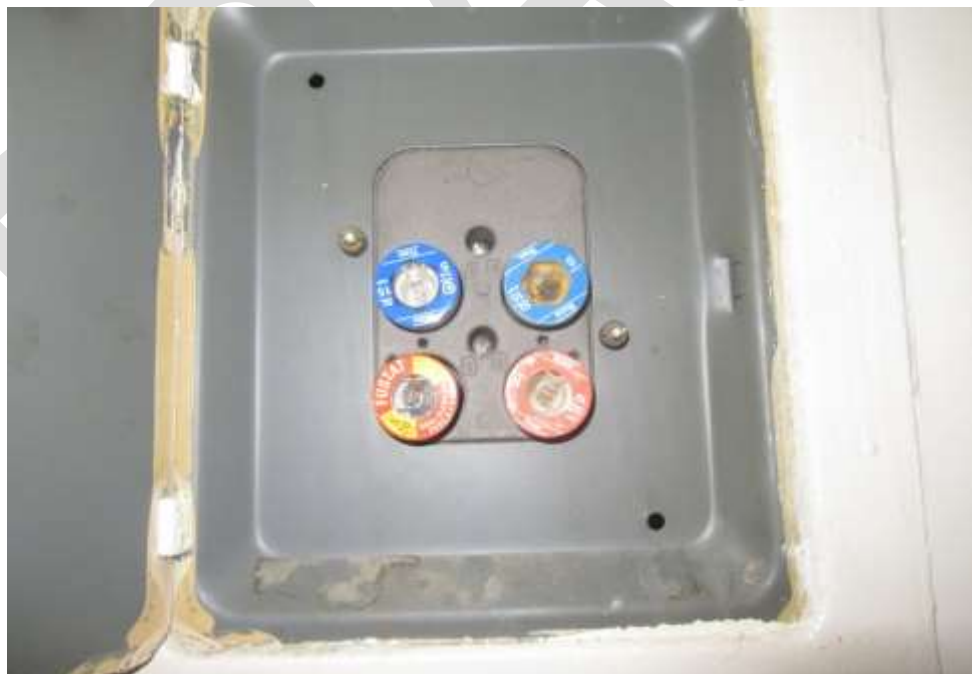
Typical Apartment Original Fused Panel
